10. The Unique Nature of the Davis-Besse Nozzle 3 Crack and the RPV Head Wastage Cavity

10.1 Wastage Cavities at Nozzles 3 and 2

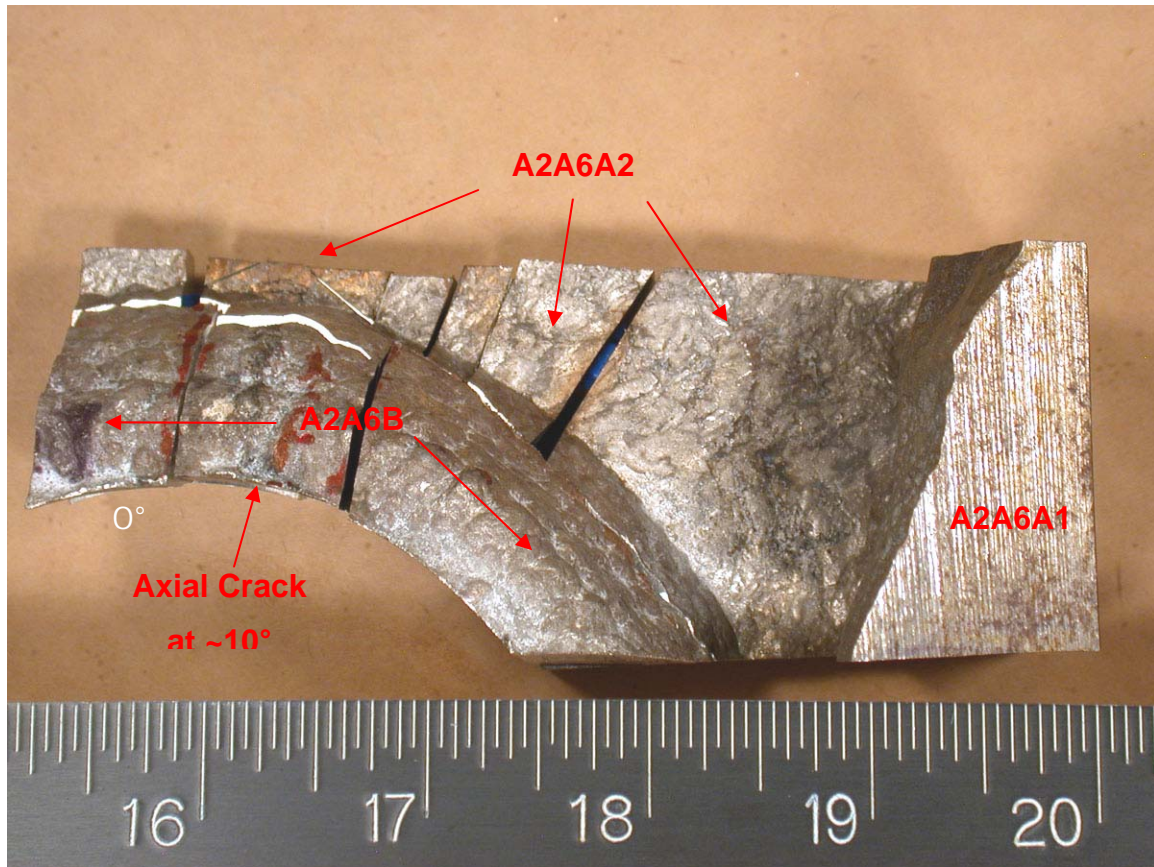
Figure 10.12 Piece A2A6 was first sectioned into Pieces A2A6A and A2A6B. Piece A2A6A was further sectioned into Pieces A2A6A1 and A2A6A2. Both cuts were made on the same plane, parallel to the paper. The first cut line is partially visible; Piece A2A6B is the upper portion of the weld. The second cut line between Pieces A2A6A1 and A2A6A2 is obscured by Piece A2A6A1

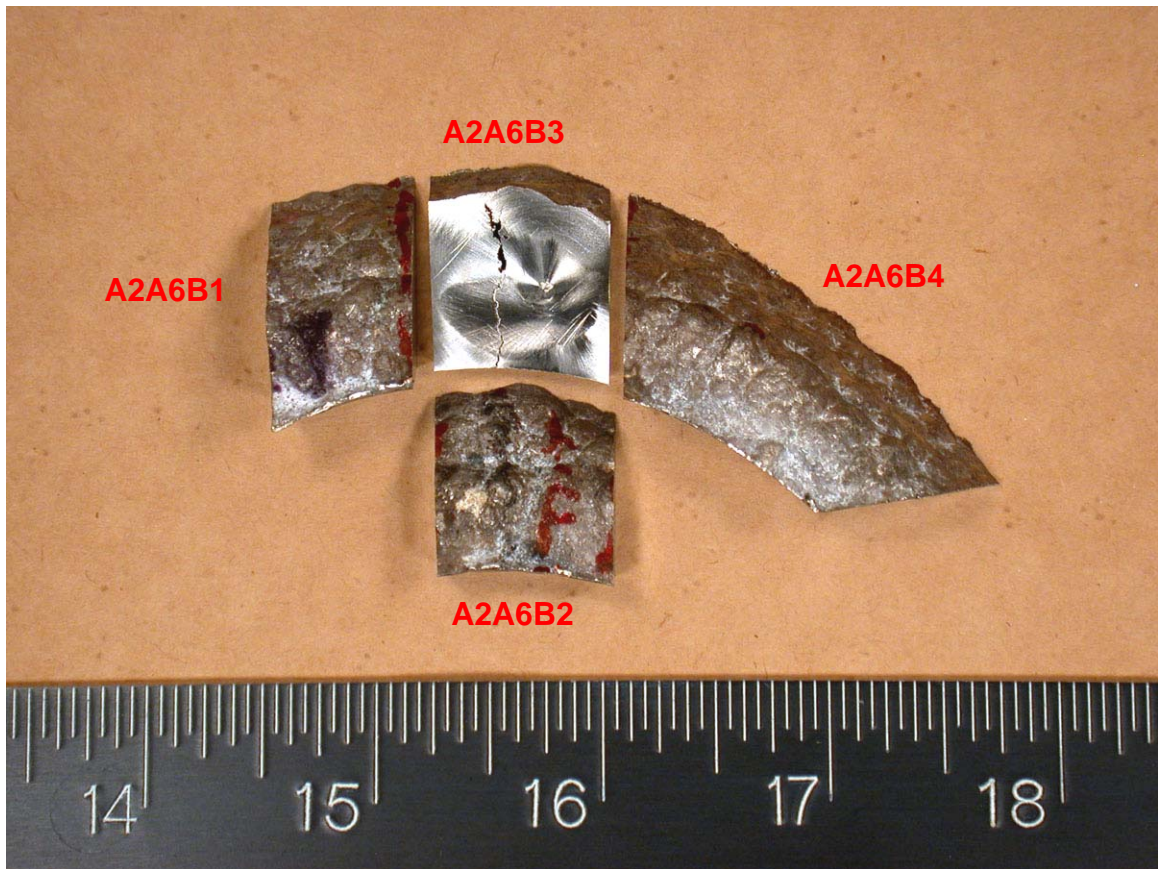
Figure 10.13 Piece A2A6B after sectioning. The bottom surface of A2A6B2 was mounted. The axial crack in A2A6B3 was opened up for SEM.
